Safety Directive 501 - Tip Cap & Tip Webbing need inspection

Status: Mandatory - All Wings are Grounded until inspection has been completed

Date: July 10, 2024

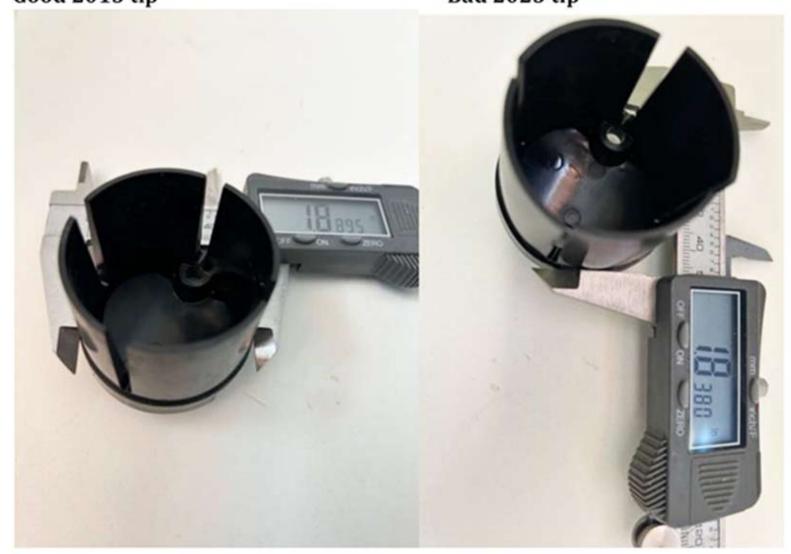
We had a run of tip caps that ran small on the body and the rim. ID 1.838" to 1.860"

They should be 1.884 to 1.891 (ranging .025 to .45 smaller) Your cap body should not be less than 1.884

Body measurement Good 2013 tip

Bad 2023 tip

If you need to replace your Tip Cap, we can sell you new 3D-printed ones for \$60 a pair.

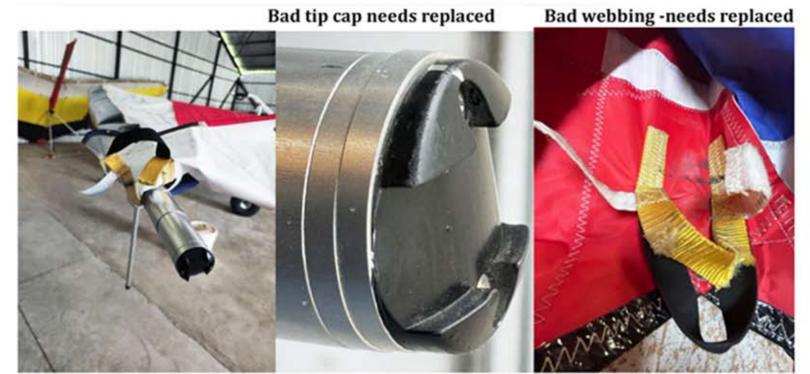
Issue: Yellow Tip Webbing abrasion from aluminum tube, cutting through webbing.

Tip Cap Shrinkage making the cap too small, and it can get pressed down into the shim tube or Leading Edge tube and causes abrasion on the Tip Webbing Strap.

Tip Cap pressed down into the Shim and alum edge can cut the Webbing

If your webbing is worn and needs to be replace we will replace webbing at no charge. Shipping cost of the sail and time we will not cover.

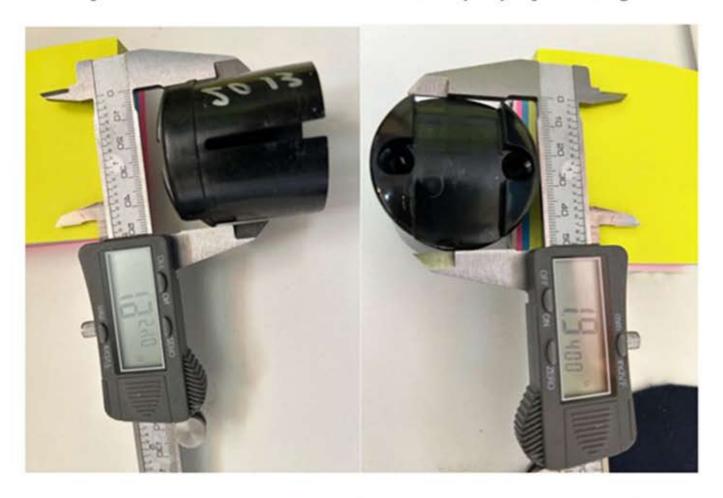
Good Tip Caps 2021 or earlier Outer lip should read 1.950 to 1.955 Could be Bad caps 2021 or newer Newer (bad) caps showing 1.940
