Strut rotation fitting Service Advisory -SA109

**Issue: Cotter pin not installed inside rotation fitting.
Lower side strut fitting to control bar.**

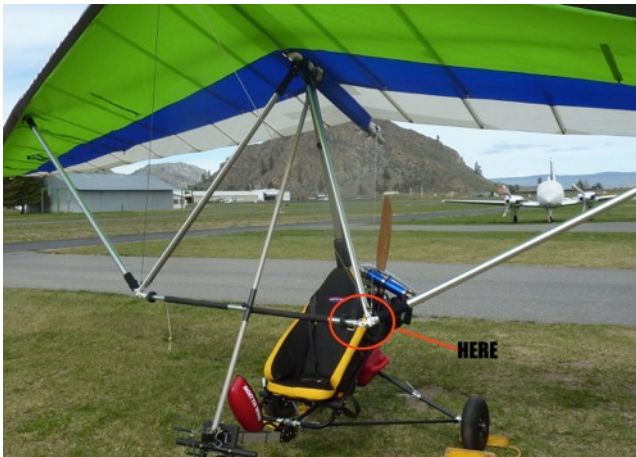
This advisory is to check the fittings on Maverick and Solairus wings from 2018 to 2020. We had one report of one wing that had no cotter pins.

**However we advise all wings to be check from 2007 to current.
Ground your wing till you have checked this!!**

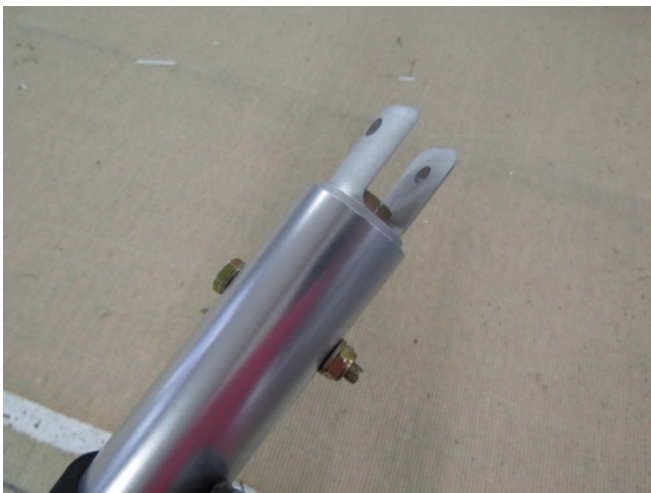
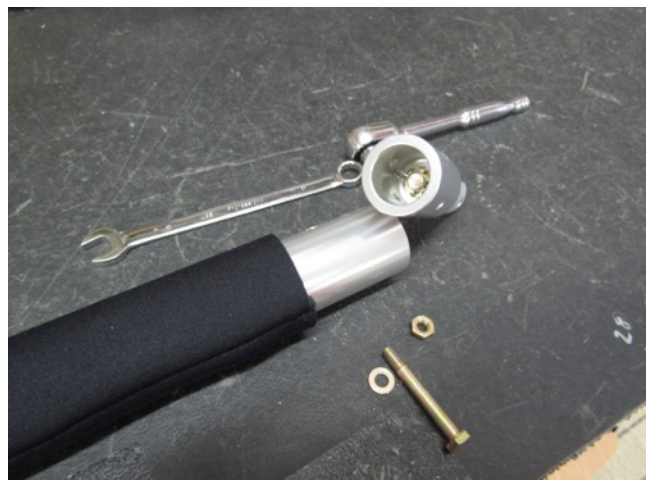
There were two types of fittings (short and long). The short ones go up inside the strut and you cannot see the cotter pin through the pin install hole. So you must take the fitting out of the strut.

Short fitting: take out of the strut to check for cotter pin install

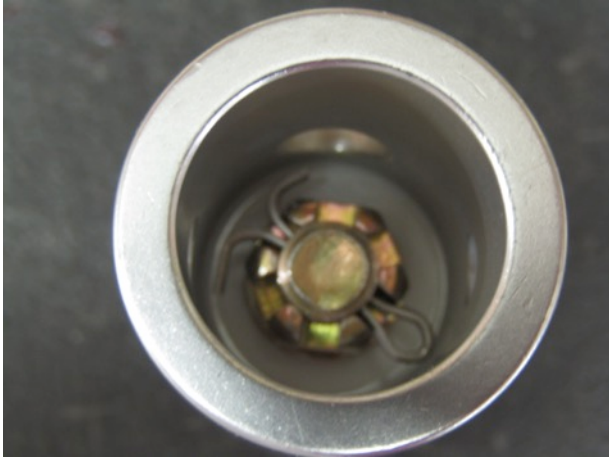
cotter pin inside

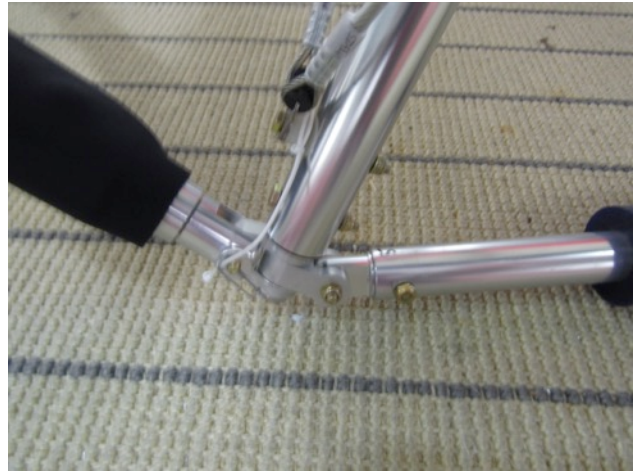
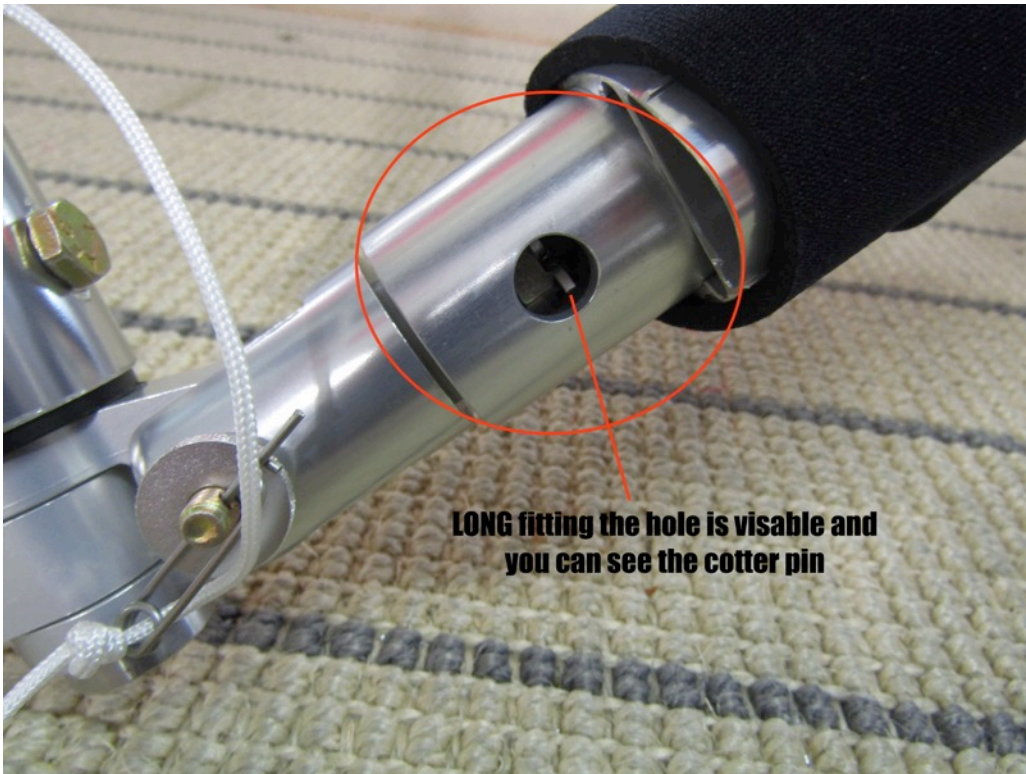
The long fitting used on two place wings (2014 forward) you can see the 3/8" install hole and you can see the cotter pin through the holes.

**LONG fitting the hole is visable and
you can see the cotter pin**
