Safety Directive 501 - Tip Cap & Tip Webbing need inspection

Status: Mandatory - All Wings are Grounded until inspection has been completed

Date: July 10, 2024

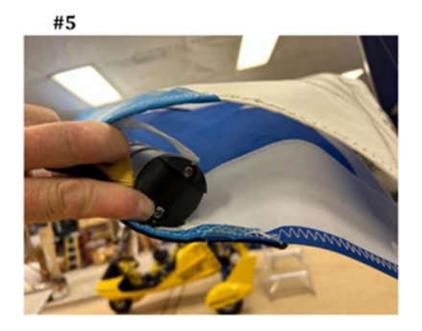
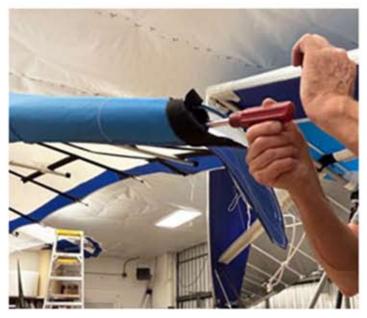
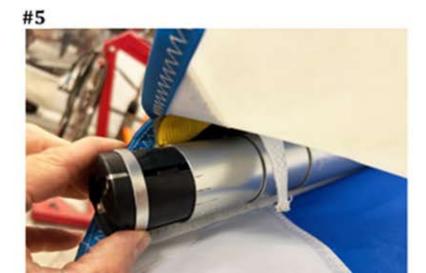
We had a run of tip caps that ran small on the body and the rim. ID 1.838" to 1.860"

They should be 1.884 to 1.891 (ranging .025 to .45 smaller) Your cap body should not be less than 1.884

5 - Now you need to take the Tip Cap out of the Leading Edge. To do this, you must release the wedge on the inside of the tip cap. Unscrew the 2 screws about 1/4" out. Now with the screw drive on the head of the screw, hit the top of the screw driver pushing the screws back flush. Now the cap can rotate and pull out.
